**Flood Control Project Maintenance
Levee Inspections**
LMA District Cover Sheet
Spring 2014 Levee Inspection Results

Reclamation District No. 0501 Ryer Island

Spring 2014 Levee Inspection Results

Waterway			Bank	Unit Miles
Unit No. 01 Steamboat Slough			Right	6.76
	Spring (March - May)	Summer (June - August)	(September - November) Fall	Winter (December - February)
Unit Maintenance Rating (Fall Only)				
Date of Inspection	04/02/2014 - 04/02/2014			
DWR Inspector	Herman Phillips			
Accompanied By	Niclas Zepeda RD 501

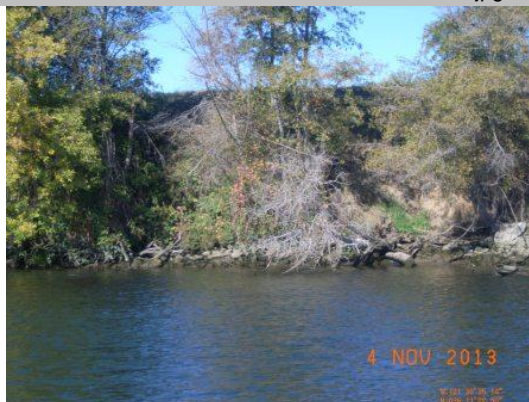
Photo 1 of 1 : USACE2013A_STM_15-7_R_5.jpg

LM Start	5.75	Rating **	M	Issue No.	3
LM End	5.75	Issue Type +	Ma	Location *	WS
Category	Supplemental			GPS Latitude/Longitude	
				Start	End
Item	USACE Erosion Survey			38.189311 °	38.190001 °
				-121.643917 °	-121.643160 °
DWR ID					
Action/Comments					
Inspector Comments: 2008 - Overstepped levee section with multiple small pockets of erosion 10 - 20 ft wide. 2013: Site has fresh erosion and taller vertical sections. [2013 Site ID: STM_15-7_R]

USACE 2013 Photo #1

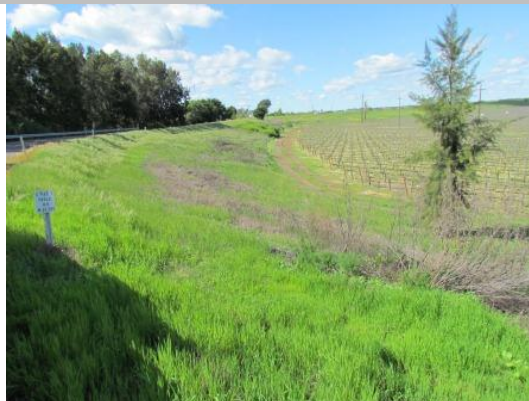
Photo 1 of 1 : phillips_s_20140527_05960.jpg

LM Start	0.00	Rating **	M	Issue No.	21
LM End	0.00	Issue Type +	Ma	Location *	LS
Category	Earthen Levee			GPS Latitude/Longitude	
				Start	End
Item	Vegetation			38.188260 °	38.188260 °
				-121.648701 °	-121.648700 °
DWR ID	DWR_RD0501_02_s _ 2012_21				
Action/Comments					
Remove the wild growth other than native grasses from the levee slopes.

Looking down stream from levee mile 0.00 landside slope.

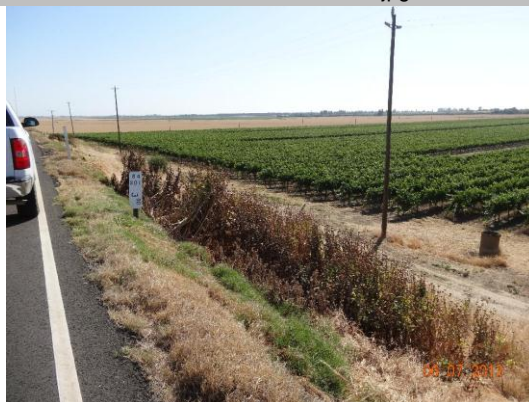
Photo 1 of 1 : UCIP_1918.jpg

LM Start	0.56	Rating **	M	Issue No.	13
LM End	0.56	Issue Type +	En	Location *	WS
Category	Supplemental			GPS Latitude/Longitude	
				Start	End
Item	DWR UCIP Field Study			38.191452 °	38.191452 °
				-121.656188 °	-121.656188 °
DWR ID	DWR_RD0501_02_s_2014_13				
Action/Comments					
Inspector Comments: FS_ID:19646					
EP_NO: N/A					
Repair Type:					
Crossing Status:					
UCIP Comments: Dense vegetation limits the inspector's visibility to identify signs of pipe failure (leaks) through the slope. Recommend removing vegetation along pipe alignment to conduct proper inspection of structure and appurtenances. Need to determine owner and purpose for crossing.					
FIELD_STRUCT_DESC: 10-inch pipe sleeved through a 12-inch pipe through the levee, 5.0 feet below the crown. Pump on waterward side. (USACE-1959). This entry matches the Drainage or Irrigation Structure referenced in O&M manual (HLM 0.60).					
FS Date: 6/7/2013

Overview of landward side.

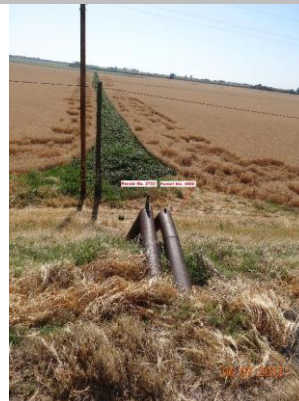
Photo 1 of 1 : UCIP_1873.jpg

LM Start	0.86	Rating **	M	Issue No.	14
LM End	0.86	Issue Type +	En	Location *	WS
Category	Supplemental			GPS Latitude/Longitude	
				Start	End
Item	DWR UCIP Field Study			38.195590 °	38.195590 °
				-121.655163 °	-121.655163 °
DWR ID	DWR_RD0501_02_s_2014_14				
Action/Comments					
Inspector Comments: FS_ID:19585					
EP_NO: 3703					
Repair Type:					
Crossing Status:					
UCIP Comments: Deteriorated pipe with holes present at intake. Dense vegetation limits the inspector's visibility to identify signs of pipe failure (leaks) through the slope. Recommend removing vegetation along pipe alignment to conduct proper inspection of structure and appurtances. If crossing is not in use--owner must remove pipe per CVFPB Title 23 requirements. Need to coordinate with DWR Inspector and CVFPB.					
FIELD_STRUCT_DESC: 8-inch steel pipe through the levee, 1.7 feet below the crown. Siphon breaker on apex of pipe at landward shoulder. Pipe discharges into concrete sump near landward toe. Pipe is exposed along landward slope. 8-inch pipes are approximately 1 foot apart on landward side. (Permit No. 3703-1961)

8-inch pipes approximately 1 foot apart located on landward slope.

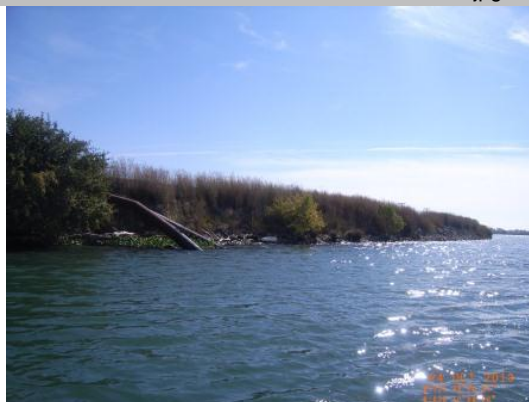
Photo 1 of 1 : USACE2013A_CHS_15-9_L_1.jpg

LM Start	1.13	Rating **	M	Issue No.	5
LM End	1.13	Issue Type +	Ma	Location *	WS
Category	Supplemental			GPS Latitude/Longitude	
				Start	End
Item	USACE Erosion Survey			38.199128 °	38.200146 °
				-121.655881 °	-121.655638 °
DWR ID					
Action/Comments					
Inspector Comments: 2005 - Large vertical sections due to wave wash. New stone dumped on the bank with exposed geotextile. Cohesive toe has thin weak stratigraphic unit that is washing out. 2006 - Partially repaired, but 100 ft in the middle of the reach has exposed filter fabric and stone riprap is gone. 2010 - Site extended downstream to include new erosion pocket. 2013: No observed changes. [2013 Site ID: CHS_15-9_L]

USACE 2013 Photo #1

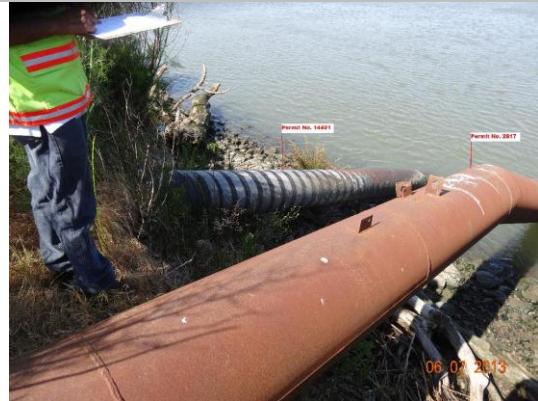
Photo 1 of 1 : UCIP_1925.jpg

UCIP Comments: Dense vegetation limits the inspector's visibility to identify signs of pipe failure (leaks) through the slope. Recommend removing vegetation along pipe alignment to conduct proper inspection of structure and appurtenances. Waterward berm is being scoured.

Waterward side--2-24 inch pipe inlets.

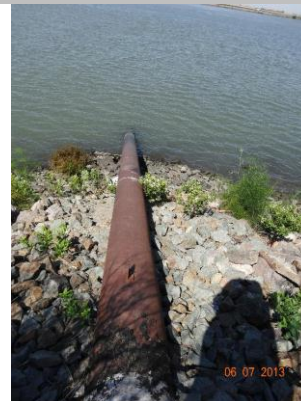
Photo 1 of 1 : UCIP_1936.jpg

LM Start	1.70	Rating **	M	Issue No.	20
LM End	1.70	Issue Type +	En	Location *	LS
Category	Supplemental			GPS Latitude/Longitude	
				Start	End
Item	DWR UCIP Field Study			38.207433 °	38.207433 °
				-121.656299 °	-121.656299 °
DWR ID	DWR_RD0501_02_s_2014_20				
Action/Comments					
Inspector Comments: FS_ID:19649 EP_NO: 13520 Repair Type: Crossing Status: UCIP Comments: Dense vegetation limits the inspector's visibility to identify signs of pipe failure (leaks) through the slope. Recommend removing vegetation along pipe alignment to conduct proper inspection of structure and appurtenances. Need to update owner's name. Owner needs to be informed about the vegetation clearance required for proper inspection. FIELD_STRUCT_DESC: 18-inch steel pipe through the levee, 3.4 feet below the crown. Steel cutoff wall around pipe at center of levee. Siphon breaker on apex of pipe on landward shoulder. Pipe extends from sump off of landward toe. Pipe exposed along waterward slope. Rock revetment on waterward slope. (Permit No. 13520-1982) FS Date: 6/7/2013

Photo of pipe looking from berm edge to river edge.

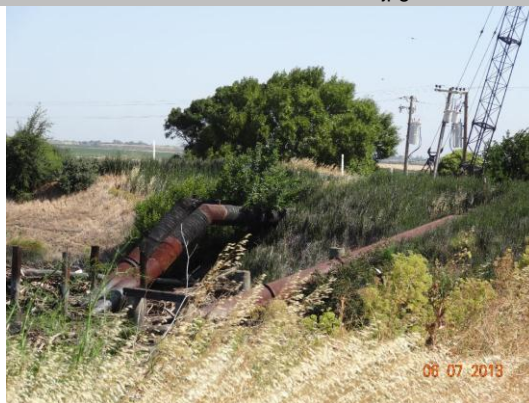
Photo 1 of 1 : UCIP_1941.jpg

LM Start	1.81	Rating **	M	Issue No.	22
LM End	1.81	Issue Type +	En	Location *	WS
Category	Supplemental			GPS Latitude/Longitude	
				Start	End
Item	DWR UCIP Field Study			38.208907 °	38.208907 °
				-121.655507 °	-121.655507 °
DWR ID	DWR_RD0501_02_s_2014_22				
Action/Comments					
Inspector Comments: FS_ID:19650					
EP_NO: N/A					
Repair Type:					
Crossing Status:					
UCIP Comments: Stacey Boyd, LMA superintendent for RD0501, confirmed the removal and replacement of existing crossing under new permit no. 18811. New crossing will be a 30-inch diameter discharge pipe above the design flood plane. Construction will start soon. Update record once the project is completed. Dense vegetation on both waterside and landside. Recommend removing vegetation along pipe alignment to conduct proper inspection of structure and appurtenances. FIELD_STRUCT_DESC: 42-inch steel pipe through the levee, 6.5 feet below the crown. Siphon breaker on waterward slope. Pump on the landward side. Pipe exposed along both slopes. (USACE-1959). This entry matches the Drainage or Irrigation Structure referenced in O&M manual (HLM 2.0).

One 42-inch steel pile with siphon break on waterside slope.

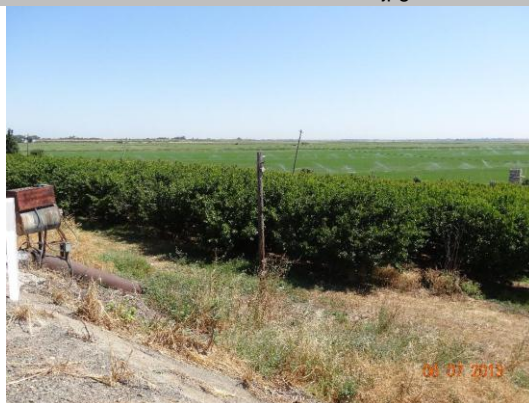
Photo 1 of 1 : UCIP_1962.jpg

LM Start	2.81	Rating **	M	Issue No.	26
LM End	2.81	Issue Type +	En	Location *	LS
Category	Supplemental			GPS Latitude/Longitude	
				Start	End
Item	DWR UCIP Field Study			38.217515 °	38.217515 °
				-121.669022 °	-121.669022 °
DWR ID	DWR_RD0501_02_s_2014_26				
Action/Comments					
Inspector Comments: FS_ID:19656					
EP_NO: 4733					
Repair Type:					
Crossing Status:					
UCIP Comments: Dense vegetation limits the inspector's visibility to identify signs of pipe failure (leaks) through the waterward slope. Recommend removing vegetation along pipe alignment to conduct proper inspection of structure and appurtenances.					
FIELD_STRUCT_DESC: 18-inch pipe through the levee, 4.0 feet below the crown. Cutoff wall around pipe at center of levee. Siphon breaker on apex of pipe at landward shoulder. Rock revetment on waterward slope. 16-inch pipe welded to 18-inch pipe near landward shoulder, extends down landward slope. Pipe exposed along both slopes. (Permit No. 4733-1964)

Overview of landward side. Pump system located near crown hinge point.

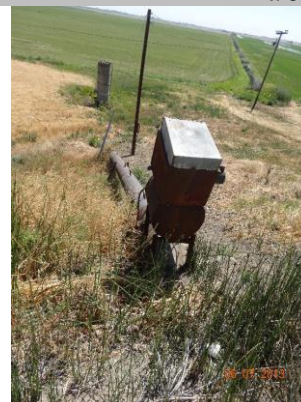
Photo 1 of 1 : UCIP_1966.jpg

LM Start	3.09	Rating **	M	Issue No.	27
LM End	3.09	Issue Type +	En	Location *	LS
Category	Supplemental			GPS Latitude/Longitude	
				Start	End
Item	DWR UCIP Field Study			38.221076 °	38.221076 °
				-121.671359 °	-121.671359 °
DWR ID	DWR_RD0501_02_s _ 2014_27				
Action/Comments					
Inspector Comments: FS_ID:19657 EP_NO: N/A Repair Type: Crossing Status: UCIP Comments: Dense vegetation limits the inspector's visibility to identify signs of pipe failure (leaks) through the waterward slope. Recommend removing vegetation along pipe alignment to conduct proper inspection of structure and appurtenances. FIELD_STRUCT_DESC: 16-inch pipe sleeved through a 20-inch pipe through the levee, 4.7 feet below the crown. Annular gap grouted. Siphon breaker on landward shoulder. Pipe exposed along both slopes. (USACE-1959). This entry matches the Drainage or Irrigation Structure referenced in O&M manual (HLM 3.30). The 16-inch pipe was sleeved through pre-existing pipe under Permit No. 2645 (1959). FS Date: 8/22/2013

Overview of landward side, includes view of exposed pipe, pump, and standpipe.

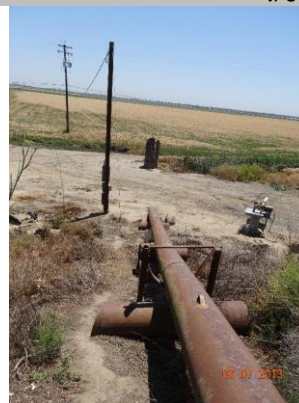
Photo 1 of 1 : UCIP_1972.jpg

LM Start	0.65	Rating **	M	Issue No.	5
LM End	0.65	Issue Type +	En	Location *	WS
Category	Supplemental			GPS Latitude/Longitude	
				Start	End
Item	DWR UCIP Field Study			38.234637 °	38.234637 °
				-121.665281 °	-121.665281 °
DWR ID	DWR_RD0501_03_s_2014_5				
Action/Comments					
Inspector Comments: FS_ID:19658					
EP_NO: N/A					
Repair Type:					
Crossing Status:					
UCIP Comments: Pump operating during inspection. Need to determine owner. Dense vegetation limits the inspector's visibility to identify signs of pipe failure (leaks) through the waterward slope. Recommend removing vegetation along pipe alignment to conduct proper inspection of structure and appurtenances.					
FIELD_STRUCT_DESC: 14-inch steel pipe through the levee, 6.3 feet below the crown instead of 16-inch pipe mentioned in O&M. Siphon breaker on landward slope. Pipe exposed on both slopes. (USACE-1959). This entry matches the Drainage or Irrigation Structure referenced in O&M manual (HLM 0.70).

View of landward side--exposed pipe section, pipe support system, power pole, and stand pipe.

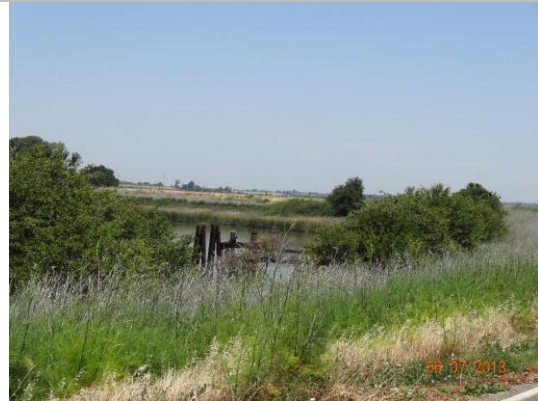
Photo 1 of 1 : UCIP_1979.jpg

LM Start	1.38	Rating **	M	Issue No.	7
LM End	1.38	Issue Type +	En	Location *	WS
Category	Supplemental			GPS Latitude/Longitude	
				Start	End
Item	DWR UCIP Field Study			38.242879 °	38.242879 °
				-121.659450 °	-121.659450 °
DWR ID	DWR_RD0501_03_s_2014_7				
Action/Comments					
Inspector Comments: FS_ID:19659					
EP_NO: N/A					
Repair Type:					
Crossing Status:					
UCIP Comments: Dense vegetation limits the inspector's visibility to identify signs of pipe failure (leaks) through the slope on both waterward and landward side. Recommend removing vegetation along pipe alignment to conduct proper inspection of structure and appurtenances.					
FIELD_STRUCT_DESC: 12-inch steel pipe through the levee, 8.0 feet below the crown. Siphon breaker on landward slope. Pump on pipe structure in stream. Concrete standpipe at landward toe. (USACE-1959). This entry matches the Drainage or Irrigation Structure referenced in O&M manual (HLM 1.50).

Overview of waterward side. Platform visible on waterward side.

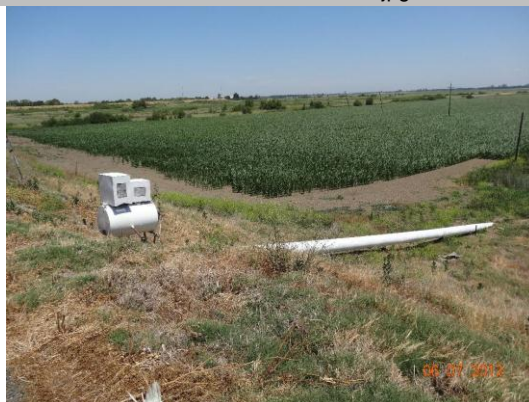
Photo 1 of 1 : UCIP_1743.jpg

LM Start	2.57	Rating **	M	Issue No.	11
LM End	2.57	Issue Type +	En	Location *	LS
Category	Supplemental			GPS Latitude/Longitude	
				Start	End
Item	DWR UCIP Field Study			38.256239 °	38.256239 °
				-121.651546 °	-121.651546 °
DWR ID	DWR_RD0501_03_s_2014_11				
Action/Comments					
Inspector Comments: FS_ID:18945					
EP_NO: N/A					
Repair Type:					
Crossing Status:					
UCIP Comments: Need to determine owner of structure. Recommend removing vegetation along pipe alignment to conduct proper inspection of structure and appurtenances.					
FIELD_STRUCT_DESC: 16-inch steel pipe through the levee, 3.3 feet below the crown. Gate valve and switch box on landward slope. Pipe exposed on both slopes. (USACE-1959) Riprap on waterward side. This entry matches the Drainage or Irrigation Structure referenced in O&M manual (HLM 2.70).					
FS Date: 6/7/2013

Overview of landward side. Pump stations, pipe section, positive closure device at landward toe.

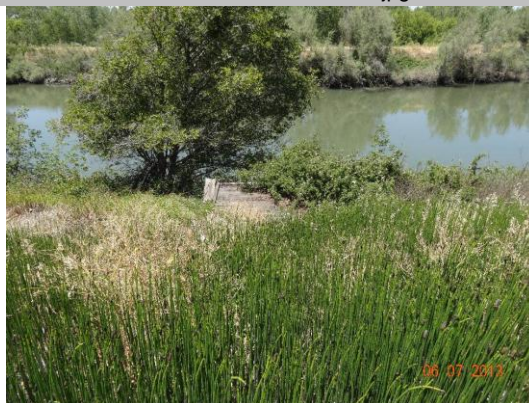
Photo 1 of 1 : UCIP_1744.jpg

Overview of waterward side with limited access to structure.

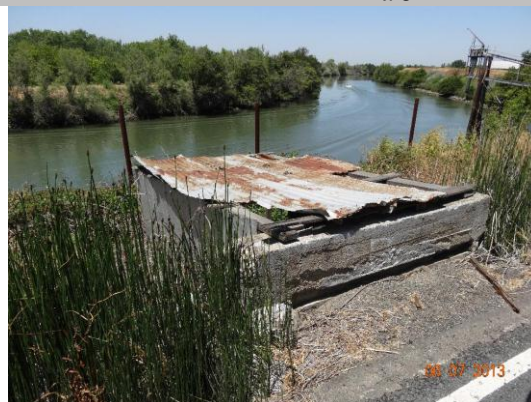
Photo 1 of 1 : UCIP_1883.jpg

LM Start	3.72	Rating **	M	Issue No.	16
LM End	3.72	Issue Type +	En	Location *	LS
Category	Supplemental			GPS Latitude/Longitude	
				Start	End
Item	DWR UCIP Field Study			38.267818 °	38.267818 °
				-121.640521 °	-121.640521 °
DWR ID	DWR_RD0501_03_s _ 2014_16				
Action/Comments					
Inspector Comments: FS_ID:19603					
EP_NO: N/A					
Repair Type:					
Crossing Status:					
UCIP Comments: Unable to properly inspect structure--limited access.					
Also unable to determine if structure is still in use. Levee logs indicate					
this crossing is abandoned. If structre is no longer used-how to prevent					
water from flowing through levee during flood season. If structure no					
longer in use owner will need to remove structure per CVFPB Title 23					
requirements.					
FIELD_STRUCT_DESC: Abandoned 5.5 x 5.5 foot concrete tunnel					
through the levee, 6.5 feet below the crown.					
FS Date: 6/7/2013

Concrete box structure located on waterward side near crown hinge point.

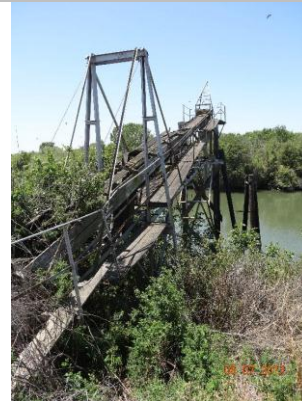
Photo 1 of 1 : UCIP_1990.jpg

FIELD_STRUCT_DESC: 36-inch pipe through the levee, 5.0 feet below the crown. Grain loading auger sleeved through the pipe. Grain loading system on platform in channel. (USACE-1959). This entry matches the Drainage or Irrigation Structure referenced in O&M manual (HLM 4.00). FS Date: 6/7/2013

Reminiscence of grain loading auger located on waterward slope.

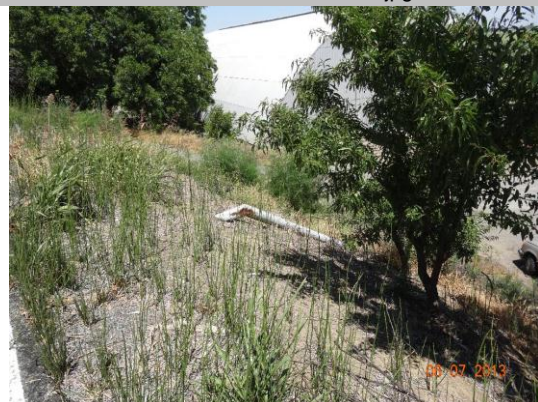
Photo 1 of 1 : UCIP_1995.jpg

FIELD_STRUCT_DESC: 6-inch pipe through the levee, 2.5 feet below the crown. Pump in pump house on waterward slope. (USACE-1959). This entry matches the Drainage or Irrigation Structure referenced in O&M manual (HLM 4.00). FS Date: 6/7/2013

View of landward side. Pipe visible.

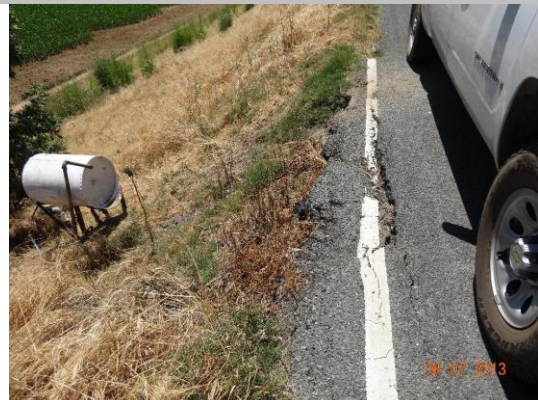
Photo 1 of 1 : UCIP_2001.jpg

LM Start	4.39	Rating **	M	Issue No.	20
LM End	4.39	Issue Type +	En	Location *	LS
Category	Supplemental			GPS Latitude/Longitude	
				Start	End
Item	DWR UCIP Field Study			38.275843 °	38.275843 °
				-121.638698 °	-121.638698 °
DWR ID	DWR_RD0501_03_s_2014_20				
Action/Comments					
Inspector Comments: FS_ID:19664 EP_NO: N/A Repair Type: Crossing Status: UCIP Comments: Damage to levee shoulder. Crossing appears to be still be in use--need to contact owner to inform about maintenance issues. Dense vegetation limits the inspector's visibility to identify signs of pipe failure (leaks) along the waterward and landward slope. Recommend removing vegetation along pipe alignment to conduct proper inspection of structure and appurtenances. FIELD_STRUCT_DESC: 24-inch pipe through the levee, 6.5 feet below the crown. Cutoff wall around pipe at waterward shoulder. Siphon breaker on apex of pipe at landward shoulder. Pump in pump house on landward slope. (USACE-1959). This entry matches the Drainage or Irrigation Structure referenced in O&M manual (HLM 4.60). 18-inch steel pipe sleeved through the 24-inch pipe under Permit No. 2496 (1957). Annular gap grouted. FS Date: 6/7/2013

View of landward side. Dry vegetation covers landward slope. Pump system located on landward slope.

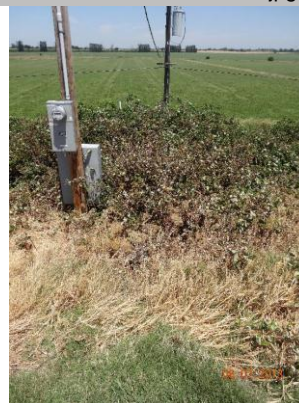
Photo 1 of 1 : UCIP_2003.jpg

FIELD_STRUCT_DESC: 12-inch concrete pipe through the levee, 2.5 feet below the crown. Cutoff wall around pipe at center of levee. Siphon breaker on apex of pipe at shoulder. Pump on pile structure in stream. Walkway access to pump. (USACE-1959). This entry matches the Drainage or Irrigation Structure referenced in O&M manual (HLM 5.10). FS Date: 6/7/2013

View of landward side. Power source and control box on landward side.

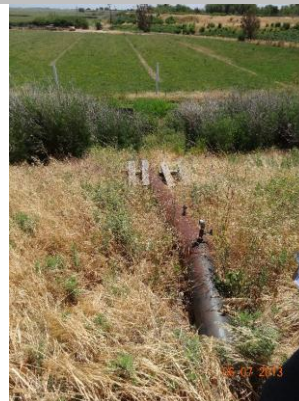
Photo 1 of 1 : UCIP_2004.jpg

LM Start	5.51	Rating **	M	Issue No.	24
LM End	5.51	Issue Type +	En	Location *	LS
Category	Supplemental			GPS Latitude/Longitude	
				Start	End
Item	DWR UCIP Field Study			38.288936 °	38.288936 °
				-121.644171 °	-121.644171 °
DWR ID	DWR_RD0501_03_s_2014_24				
Action/Comments					
Inspector Comments: FS_ID:19666					
EP_NO: N/A					
Repair Type:					
Crossing Status:					
UCIP Comments: Need to find owner and permit number authorizing work. Dense vegetation limits the inspector's visibility to identify signs of pipe failure (leaks) along the waterward and landward slopes. Recommend removing vegetation along pipe alignment to conduct proper inspection of structure and appurtenances.					
FIELD_STRUCT_DESC: 12-inch pipe through the levee, 3.0 feet below the crown. Pump on pile structure in stream.					
FS Date: 6/7/2013

View of pipe on landward side. Dry vegetation covers landward slope.

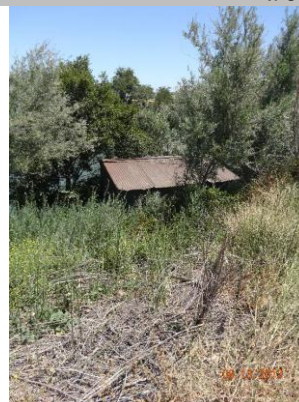
Photo 1 of 1 : UCIP_2011.jpg

View of waterward side. Dense vegetation along levee slope.

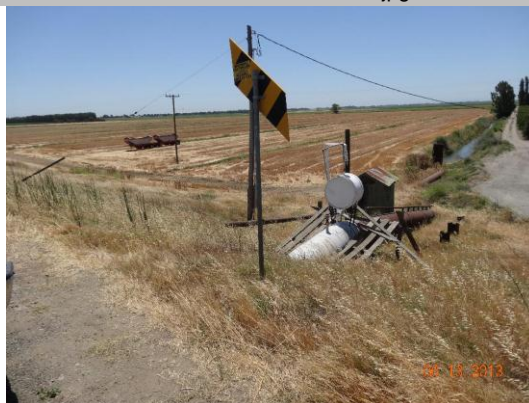
Photo 1 of 1 : UCIP_2015.jpg

UCIP Comments: Crossing was operating during inspection; Dense vegetation limits the inspector's visibility to identify signs of pipe failure (leaks) along the waterward slope. Recommend removing vegetation along pipe alignment to conduct proper inspection of structure and appurtenances.

Overview of crossing located on landward side.

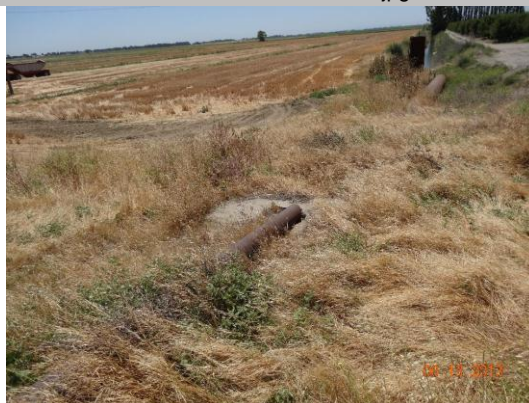
Photo 1 of 1 : UCIP_2024.jpg

Action/Comments					
Inspector Comments: FS_ID:19670					
EP_NO: N/A					
Repair Type:					
Crossing Status:					
UCIP Comments: Dense vegetation limits the inspector's visibility to identify signs of pipe failure (leaks) along the waterward slope. Recommend removing vegetation along pipe alignment to conduct proper inspection of structure and appurtenances. If crossing is not being used owner will need to remove per CVFPB Title 23 requirements. Need to find pipe owner.					
FIELD_STRUCT_DESC: Abandoned 8-inch steel pipe through the levee, 2.7 feet below the crown. Siphon breaker on apex of pipe at landward shoulder. Surge chamber at landward toe. Pump near waterward toe. Pipe exposed on landward side. (USACE-1959). Concrete platform 4 feet by 3 feet located on landward toe. 3-inch conduit runs along 8-inch steel pipe. This entry matches the Drainage or Irrigation Structure referenced in O&M manual (HLM 6.90). FS Date: 6/13/2013

Pipe at levee toe and enters concrete box.

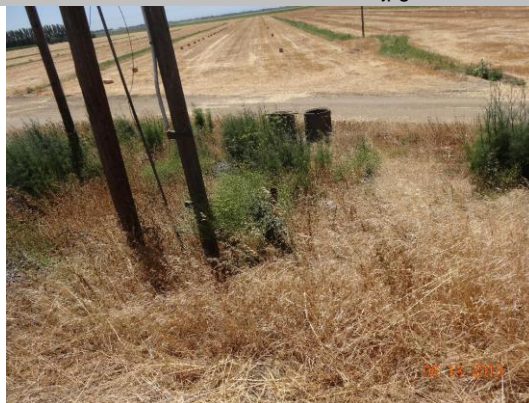
Photo 1 of 1 : UCIP_2027.jpg

Walkway missing but platform remain on the waterward side. Dense vegetation limits the inspector's visibility to identify signs of pipe failure (leaks) along the slope. Recommend removing vegetation along pipe alignment to conduct proper inspection of structure and appurtenances.

View of standpipes located on landward side.

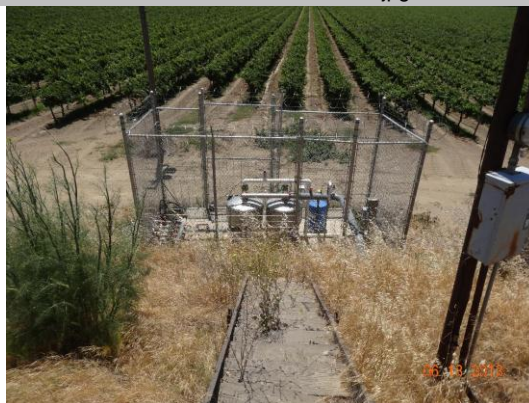
Photo 1 of 1 : UCIP_2034.jpg

LM Start	7.35	Rating **	M	Issue No.	34
LM End	7.35	Issue Type +	En	Location *	WS
Category	Supplemental			GPS Latitude/Longitude	
				Start	End
Item	DWR UCIP Field Study			38.287825 °	38.287825 °
				-121.613418 °	-121.613418 °
DWR ID	DWR_RD0501_03_s_2014_34				
Action/Comments					
Inspector Comments: FS_ID:19672					
EP_NO: N/A					
Repair Type:					
Crossing Status:					
UCIP Comments: Conduit visible on landward side; new gate on WS toe; filtration system with security fence; Pipe has been upgraded--need permit authorizing work and owner. Dense vegetation limits the inspector's visibility to identify signs of pipe failure (leaks) along the waterward slope. Recommend removing vegetation along pipe alignment to conduct proper inspection of structure and appurtenances. FIELD_STRUCT_DESC: 8-inch steel pipe through the levee, 3.7 feet below the crown. Siphon breaker and service pole on landward slope. 2-inch conduit runs parallel to 8-inch steel pipe. Pump in pump house on waterward slope. (USACE-1959). This entry matches the Drainage or Irrigation Structure referenced in O&M manual (HLM 8.00).

Pipe line connects to sytem located at the toe of the levee.

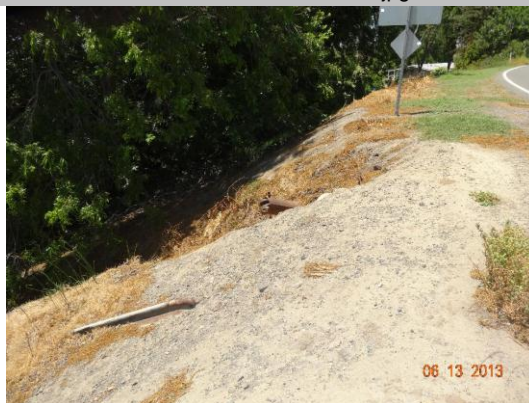
Photo 1 of 1 : UCIP_2039.jpg

Action/Comments					
Inspector Comments: FS_ID:19673					
EP_NO: N/A					
Repair Type:					
Crossing Status:					
UCIP Comments: Abandoned section of pipe located on waterward berm. Dense vegetation limits the inspector's visibility to identify signs of pipe failure (leaks) along the waterward slope. Recommend removing vegetation along pipe alignment to conduct proper inspection of structure and appurtenances.					
FIELD_STRUCT_DESC: 8-inch steel pipe through the levee, 2.7 feet below the crown. Pump in pump house at landward toe. (USACE-1959). This entry matches the Drainage or Irrigation Structure referenced in O&M manual (HLM 8.20).					
FS Date: 6/13/2013

Side view of crossing on landward side. Exposed levee section along landward slope.

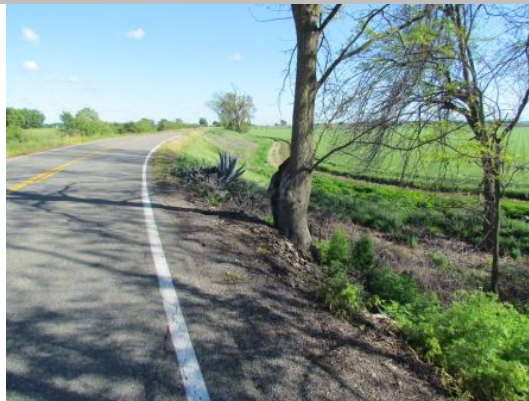
Photo 1 of 1 : phillips_s_20140527_05956.jpg

LM Start	0.00	Rating **	M	Issue No.	5
LM End	0.00	Issue Type +	Ma	Location *	LS
Category	Earthen Levee			GPS Latitude/Longitude	
				Start	End
Item	Vegetation			38.285591 °	38.285591 °
				-121.606317 °	-121.606317 °
DWR ID	DWR_RD0501_04_s_2012_5				
Action/Comments					
Remove the wild growth other than native grasses from the levee slopes.

Unit 4 looking downstream from levee mile 0.00.

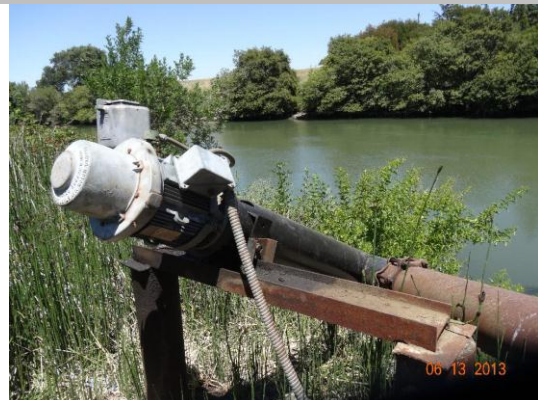
Photo 1 of 1 : UCIP_1759.jpg

LM Start	0.56	Rating **	M	Issue No.	2
LM End	0.56	Issue Type +	En	Location *	LS
Category	Supplemental			GPS Latitude/Longitude	
				Start	End
Item	DWR UCIP Field Study			38.278848 °	38.278848 °
				-121.601216 °	-121.601216 °
DWR ID	DWR_RD0501_04_s_2014_2				
Action/Comments					
Inspector Comments: FS_ID:19069					
EP_NO: 2446					
Repair Type:					
Crossing Status:					
UCIP Comments: Cracks visible on levee crown could be associated with pipe vibration or settlement. Burrow activity on landward side. Recommend removing vegetation along pipe alignment on landward side to conduct proper inspection of structure and appurtenances.					
FIELD_STRUCT_DESC: 10-inch iron pipe through the levee, 3.5 feet below the crown. Cutoff wall around pipe at landward shoulder. Slant pump and pump house on waterward slope. Concrete standpipe and power pole at landward toe. Service pole on landward slope. Pipe exposed on both slopes. (Permit No. 2446-1957) Section of pipe under levee crown, between both shoulders, was removed and replaced with a 10-inch steel pipe under Permit No. 18135 (2006). Two crossings nearby 10-inch pipe and 8-inch pipe crossings are approximately 5 feet apart.

Slant pump located on waterward side. 10 inch pipe connects at an angle to tar coated pipe.

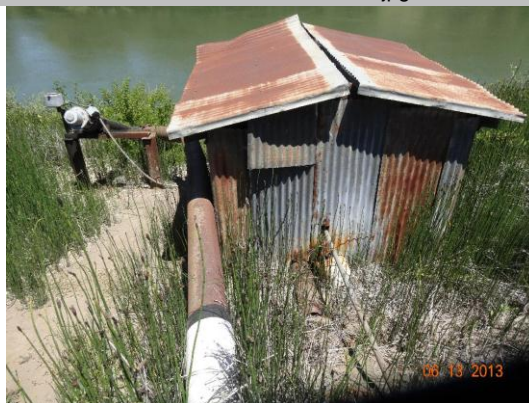
Photo 1 of 1 : UCIP_2044.jpg

LM Start	0.56	Rating **	M	Issue No.	6
LM End	0.56	Issue Type +	En	Location *	LS
Category	Supplemental			GPS Latitude/Longitude	
				Start	End
Item	DWR UCIP Field Study			38.278831 °	38.278831 °
				-121.601213 °	-121.601213 °
DWR ID	DWR_RD0501_04_s_2014_6				
Action/Comments					
Inspector Comments: FS_ID:19674					
EP_NO: N/A					
Repair Type:					
Crossing Status:					
UCIP Comments: Permit documents that pipe does not appear to be properly grouted. Crossing needs to be properly abandoned per CVFPB Title 23--need to find owner. Also recommend removing vegetation along pipe alignment to conduct proper inspection of structure and appurtenances.					
FIELD_STRUCT_DESC: Abandoned 8-inch steel pipe through the levee, 6.0 feet below the crown. Pump on waterward side. Steel plate welded on waterward end. (USACE-1959). This entry matches the Drainage or Irrigation Structure referenced in O&M manual (HLM 0.60). Pipe was abandoned under Permit No. 2446 (1957). 10-inch steel pipe is located approximately 5 feet downstream.

Pump house is associated with abandoned 8 inch pipe.

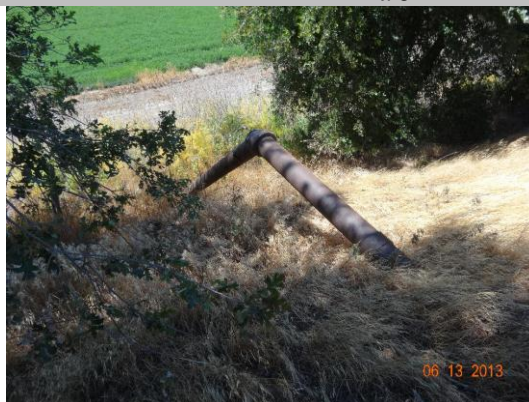
Photo 1 of 1 : UCIP_1898.jpg

LM Start	1.06	Rating **	M	Issue No.	9
LM End	1.06	Issue Type +	En	Location *	LS
Category	Supplemental			GPS Latitude/Longitude	
				Start	End
Item	DWR UCIP Field Study			38.272053 °	38.272053 °
				-121.604176 °	-121.604176 °
DWR ID	DWR_RD0501_04_s _ 2014_9				
Action/Comments					
Inspector Comments: FS_ID:19624					
EP_NO: N/A					
Repair Type:					
Crossing Status:					
UCIP Comments: Pipe has deteriorated-holes present on landward side. Owner needs to be abandon properly. Dense vegetation limits the inspector's visibility to identify signs of pipe failure (leaks) along the waterward slope. Recommend removing vegetation along pipe alignment to conduct proper inspection of structure and appurtances.					
FIELD_STRUCT_DESC: Abandoned 8-inch steel pipe through the levee, 2.7 feet below the crown. Pump on waterward side. Steel plate welded on waterward end. (USACE-1959). This entry matches the Drainage or Irrigation Structure referenced in O&M manual (HLM 1.10).

View of crossing on landward side.

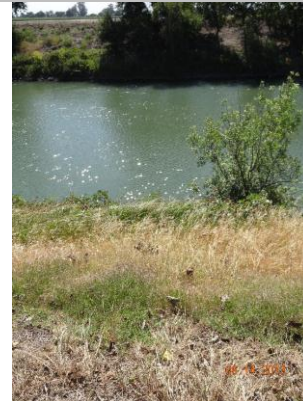
Photo 1 of 1 : UCIP_2050.jpg

LM Start	1.11	Rating **	M	Issue No.	12
LM End	1.11	Issue Type +	En	Location *	LS
Category	Supplemental			GPS Latitude/Longitude	
				Start	End
Item	DWR UCIP Field Study			38.271400 °	38.271400 °
				-121.604368 °	-121.604368 °
DWR ID	DWR_RD0501_04_s_2014_12				
Action/Comments					
Inspector Comments: FS_ID:19675					
EP_NO: N/A					
Repair Type:					
Crossing Status:					
UCIP Comments: Unable to determine if the pipe goes through the					
levee; is this an authorized encroachment?--need As-Built drawings;					
Need owner information.					
FIELD_STRUCT_DESC: 1.5-inch conduit through the levee, 2.0 feet					
below the crown. Pole and anchor on landward slope.					
FS Date: 6/13/2013

View of waterward side.

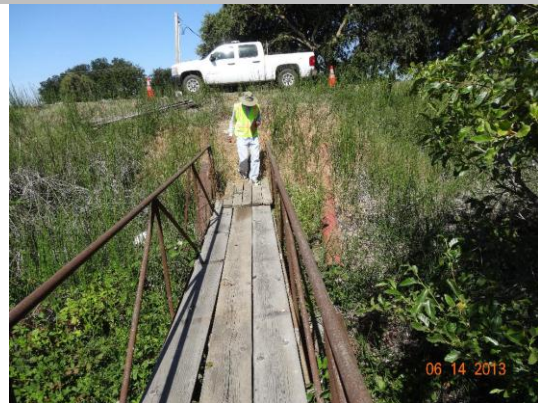
Photo 1 of 1 : UCIP_2055.jpg

LM Start	1.20	Rating **	M	Issue No.	15
LM End	1.20	Issue Type +	En	Location *	LS
Category	Supplemental			GPS Latitude/Longitude	
				Start	End
Item	DWR UCIP Field Study			38.270171 °	38.270171 °
				-121.604403 °	-121.604403 °
DWR ID	DWR_RD0501_04_s_2014_15				
Action/Comments					
Inspector Comments: FS_ID:19676					
EP_NO: N/A					
Repair Type:					
Crossing Status:					
UCIP Comments: Abandoned pipe visible on waterward side--could be the pipe that was supposed to be removed under permit number 13983 (1985). Also present is an abandoned 1.5 inch conduit along the 8 inch pipe. Need to coordinate with owner.					
FIELD_STRUCT_DESC: 8-inch steel pipe through the levee, 6.4 feet below the crown. Pump on pile structure in stream. Service pole on landward slope. (USACE-1959). This entry matches the Drainage or Irrigation Structure referenced in O&M manual (HLM 1.30). Pipe should have been removed and replaced with 12-inch pipe under Permit No. 13983 (1985).

Abandoned pipe to the right of walkway.

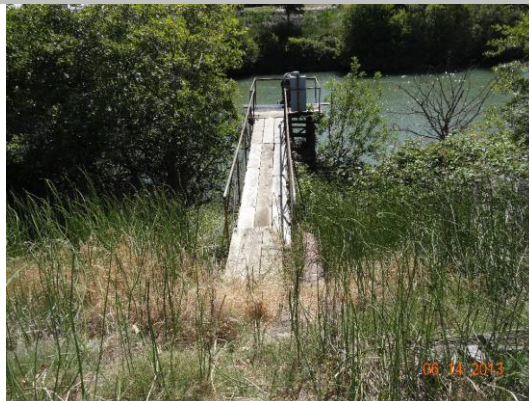
Photo 1 of 1 : UCIP_1784.jpg

UCIP Comments: Abandoned pipe was to be removed during the installation of new 12-inch pipe crossing. Need to contact with pipe owner. SEE CROSSING immediately downstream at levee mile 1.197. FIELD_STRUCT_DESC: 12-inch steel pipe through the levee, 5.0 feet below the crown. Cutoff wall around pipe at center of levee. Siphon breaker on apex of pipe at landward shoulder. Pump on pile structure in stream. Service pole on landward slope. Pipe connects to 10-inch steel pipe along the landward slope at the shoulder, and similarly to pre-existing 8-inch pipe on the watereward side. (Permit No. 13983-1985) FS Date: 6/13/2013

View of waterward side--walkway, pump, conduit, and pipe.

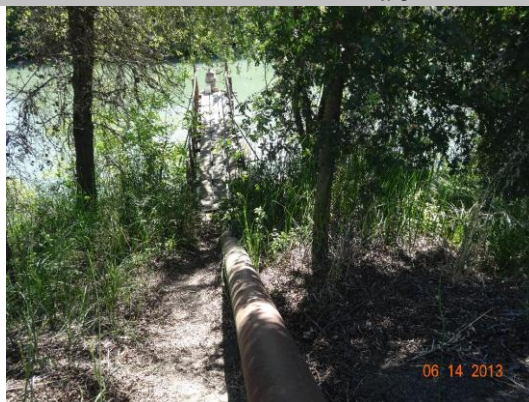
Photo 1 of 1 : UCIP_2057.jpg

LM Start	1.77	Rating **	M	Issue No.	17
LM End	1.77	Issue Type +	En	Location *	LS
Category	Supplemental			GPS Latitude/Longitude	
				Start	End
Item	DWR UCIP Field Study			38.262235 °	38.262235 °
				-121.601705 °	-121.601705 °
DWR ID	DWR_RD0501_04_s _ 2014_17				
Action/Comments					
Inspector Comments: FS_ID:19677					
EP_NO: 16906					
Repair Type:					
Crossing Status:					
UCIP Comments: Crossing was running during site inspection. Dense vegetation limits the inspector's visibility to identify signs of pipe failure (leaks) along the landward slope. Recommend removing vegetation along pipe alignment to conduct proper inspection of structure and appurtenances.					
FIELD_STRUCT_DESC: 14-inch steel pipe through the levee, 21.2 feet below the crown. Pump on pile structure in stream. Concrete standpipe on landward side. Pipe is exposed on landward slope. (Permit No. 16906-1999) Two conduits present 3 inch conduit disconnected and 1.5 inch electrical conduit appears to be active.

View of waterward side--pipe, catwalk, pump, and conduit.

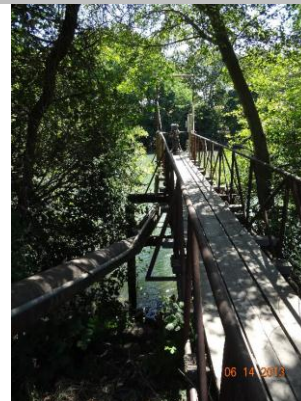
Photo 1 of 1 : UCIP_2065.jpg

LM Start	1.90	Rating **	M	Issue No.	20
LM End	1.90	Issue Type +	En	Location *	LS
Category	Supplemental			GPS Latitude/Longitude	
				Start	End
Item	DWR UCIP Field Study			38.260407 °	38.260407 °
				-121.601365 °	-121.601365 °
DWR ID	DWR_RD0501_04_s_2014_20				
Action/Comments					
Inspector Comments: FS_ID:19678					
EP_NO: N/A					
Repair Type:					
Crossing Status:					
UCIP Comments: Unable to verify if comment from historical levee log (1980) indicating pipe was leaking is true. Dense vegetation limits the inspector's visibility to identify signs of pipe failure (leaks) along the waterward and landward slope. Recommend removing vegetation along pipe alignment to conduct proper inspection of structure and appurtenances.					
FIELD_STRUCT_DESC: 14-inch steel pipe through the levee, 8.0 feet below the crown. 2 inch conduit goes through levee. Siphon breaker on landward slope. Pump on pile structure in stream. (USACE-1959). This entry matches the Drainage or Irrigation Structure referenced in O&M manual (HLM 2.0).

Waterward side--catwalk, conduit line, pump, and support piles.

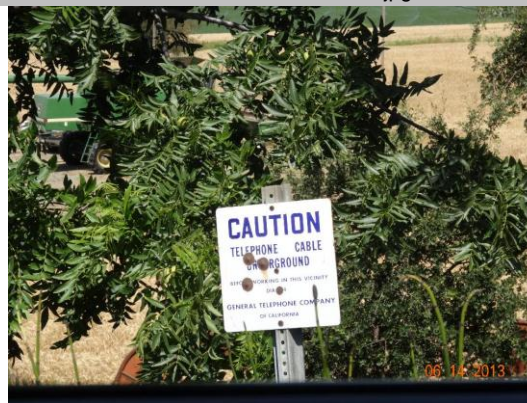
Photo 1 of 1 : UCIP_2069.jpg

UCIP Comments: Marker missing on waterward side--need to contact owner.

Marker visible on landward side.
